NAVAL POSTGRADUATE SCHOOL

**DAMAGE DETECTION IN COMPOSITE INTERFACES
THROUGH CARBON NANOTUBE REINFORCEMENT**

12 February 2010

Prepared for: Air Force Office of Scientific Research (AFOSR), Arlington VA.

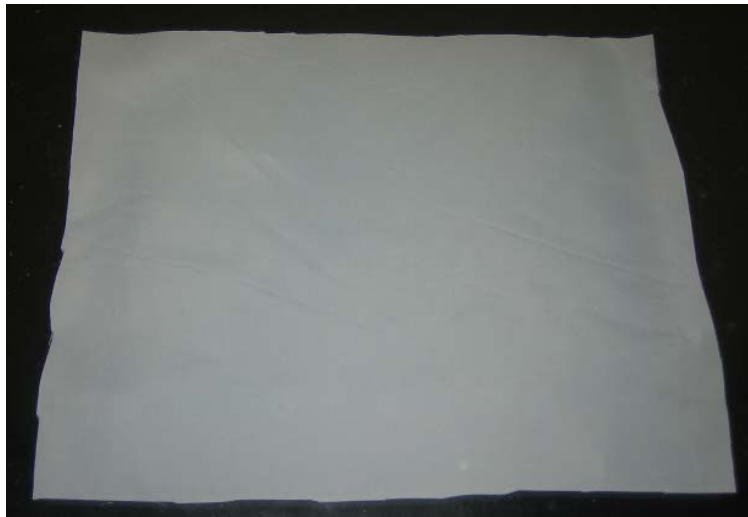
Figure 5. Peel ply laid on top of distribution media for co-cured samples.

To begin making the two-step cured samples, a layer of peel ply was placed on a piece of glass to allow for easy removal of the sample upon completion of the VARTM process. The glass used must be at least 1.27 cm (0.5 in) thick, in order to be able to withstand the extreme heat generated during the resin curing process. When making a co-cured sample, a layer of distribution media is laid down first, covered by a layer of peel ply, as shown in Figures 4 and 5.

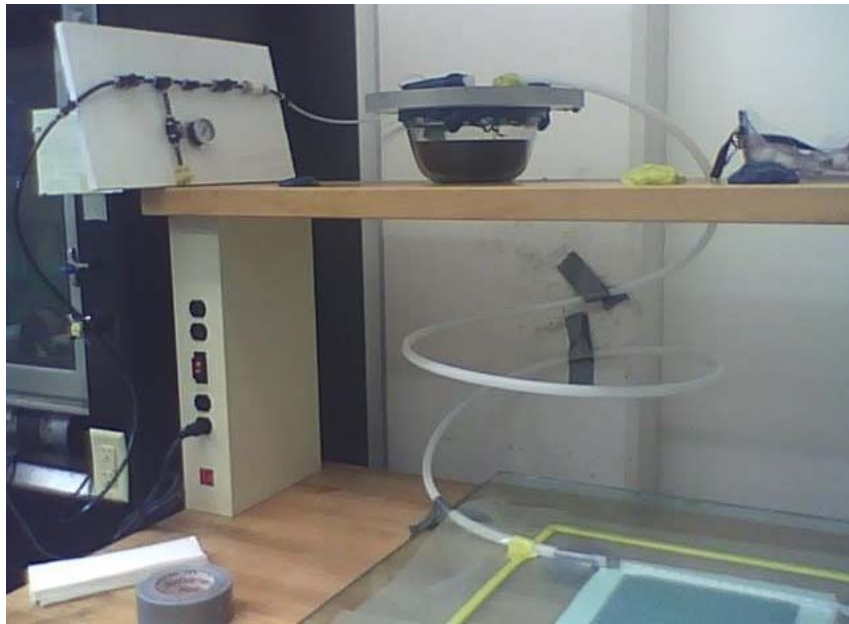
Figure 8. Gage board and resin trap.

In order for the resin to be pulled through the fiber material, a Rietschel Thomas Vacuum Pump model 2688CE44 was used. Tubing was hooked up to this pump and run through a gauge board to a resin trap, as shown in Figure 8. The resin trap was used to protect both the pump and gauge board from excess resin. From the resin trap, solid ½-inch diameter plastic tubing was measured and cut to be used inside the vacuum bag as the outlet for the resin. This same tubing was used to suck resin from the bottom of the sample to the top. Attached to both the inlet and outlet tubes, and spread across the top and bottom of the sample, was spiral tubing, as shown in Figure 9. This tubing allowed for an even distribution of the resin throughout the sample.

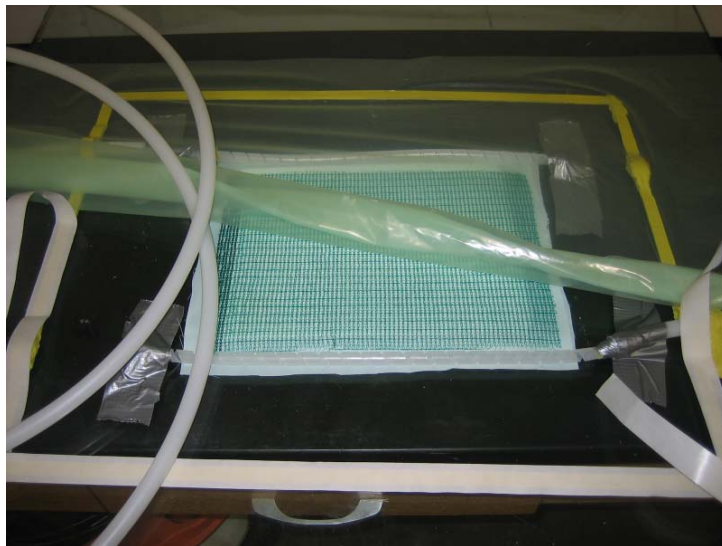
Figure 11. Rolling out the plastic sheet used to form the vacuum bag.

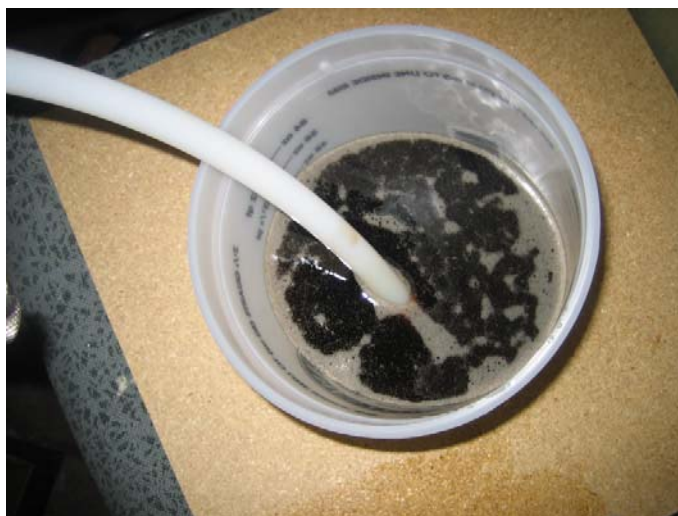
Figure 13. Resin at inlet with bubbles after mixing.

While the vacuum was still running, the temperature was noted and the appropriate amounts of resin and hardeners were mixed to ensure a 60-minute cure time. Once mixed, the resin was transferred to the inlet of the vacuum bag and the inlet tube was clamped to prevent the resin from flowing through the sample. As a result of mixing and transferring the resin to a new bucket, small bubbles are formed throughout the resin, seen in Figure 13. Enough time (about 10-15 minutes), was allowed for these bubbles to dissipate before running the resin through the sample. If allowed to run through the sample, these bubbles would have gotten caught and ruined the sample.

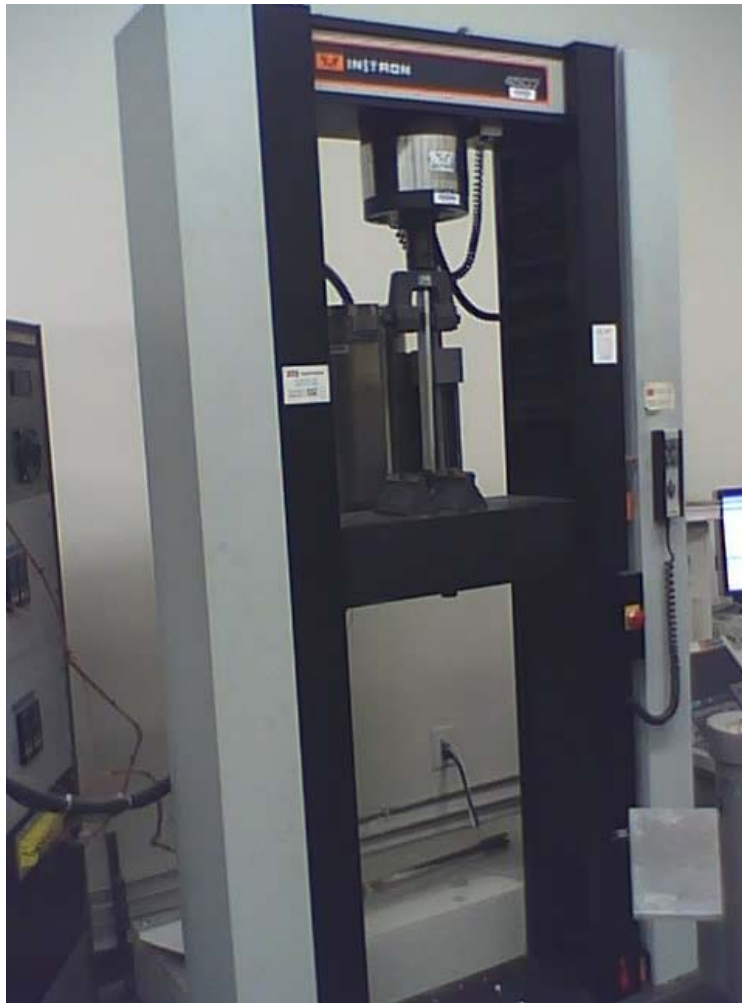
Figure 19. Mode II test setup in Instron test machine.

All tests were conducted using an Instron Tension/Compression Machine (Model Number: 4507/4500), shown in Figure 19. All testing phases were conducted using a 10-kN load cell. Collection of data generated by the Instron was done by a Series IX computer software which was also used to control the Instron to achieve desired test requirements. Additionally, for Phase III, IV, and V, the coupons were hooked up to a Fluke 8840A multi-meter as displayed in Figure 20. This device was used to measure the resistance within the coupons throughout the entire test period. Data produced from this machine was collected by hand at 30-second intervals.

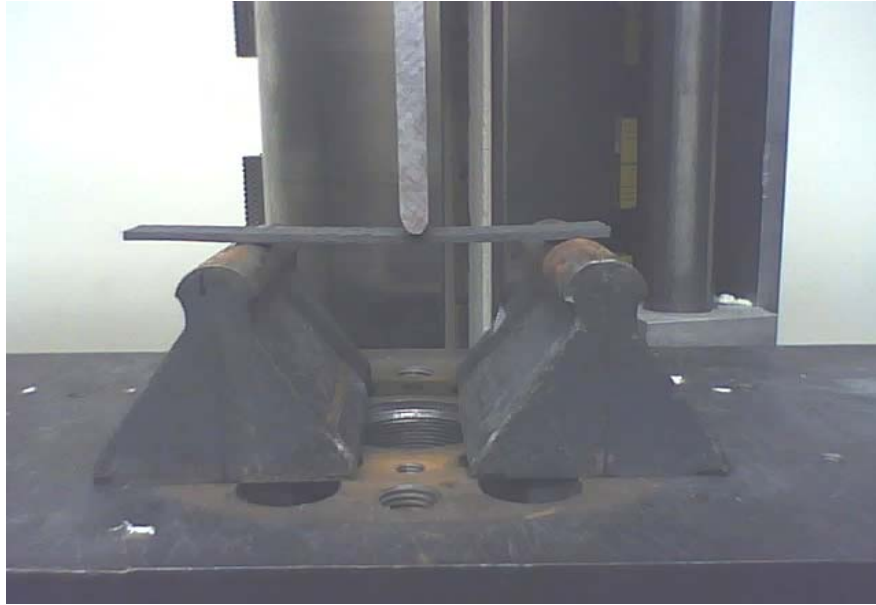
Figure 22. Picture of three-point bending test for Mode II.

The setup used is shown in Figures 21 and 22. For all tests, the Instron held the center support stationary, attached to the load cell, while the base supports were incrementally moved up into the stationary support. The higher the base moved the greater the load felt on the coupon became, resulting in higher shear stresses felt at the crack tip. A plot of force versus displacement was provided from the Series IX computer software and used to help calculate the Mode II critical strain energy release rate, G_{II} .

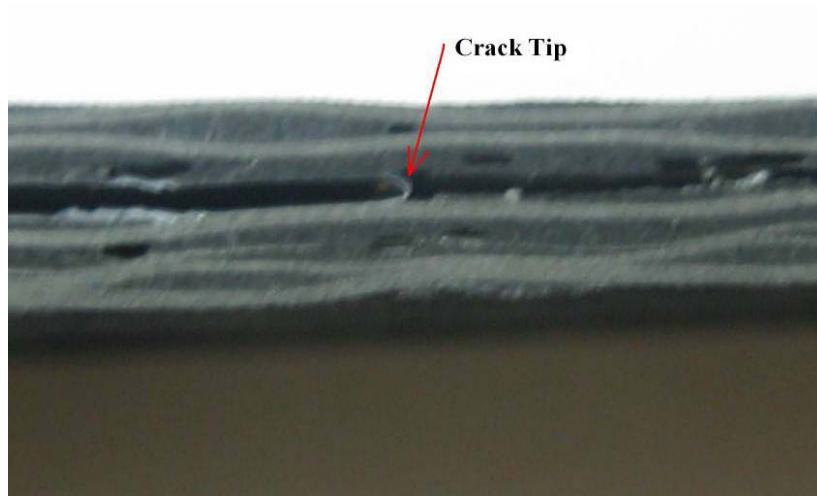
Figure 24. Crack propagation path for a co-cured carbon fiber coupon.

Upon further investigation, it was observed that the crack propagation was similar for both the two-step cured and co-cured sample sets. For both cases, the crack initially propagated from the built-in crack tip and ran along the centerline of the coupon perpendicular to the load application. Figures 24 and 25 show the path of crack propagation as described.

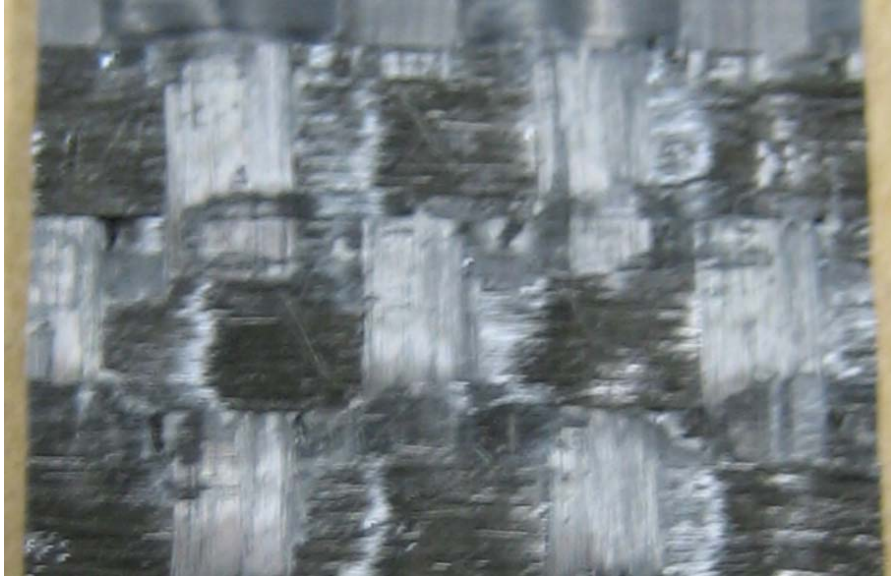
Figure 26. Surface crack propagation path for a co-cured coupon.

After testing was complete, coupons in which crack propagation occurred were pulled apart to inspect the cracked surface. Both the co-cured and two-step cured coupons experienced the same type of failure. In some areas, the joint interface bond was

broken through the resin, while in others the resin was pulled away from the fibers, as shown in Figures 26 and 27.

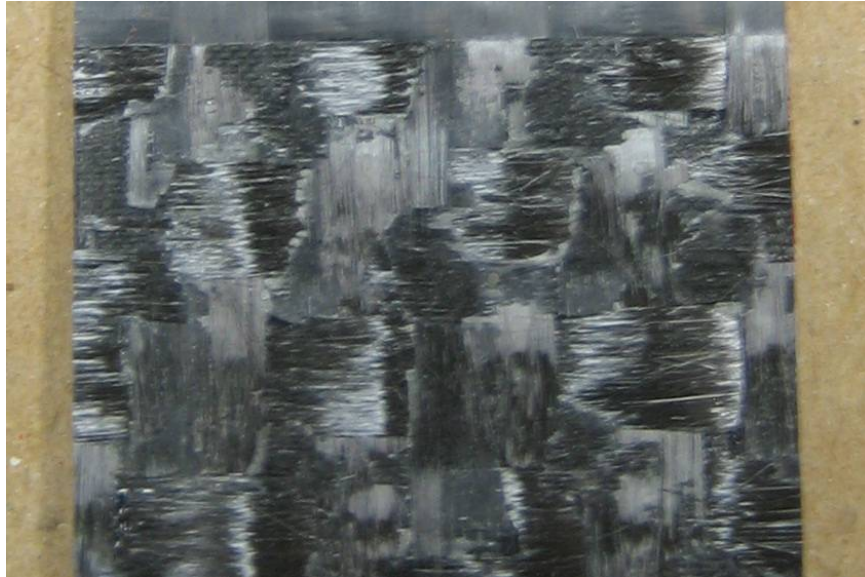
Figure 27. Surface crack propagation path for a two-step cured coupon.

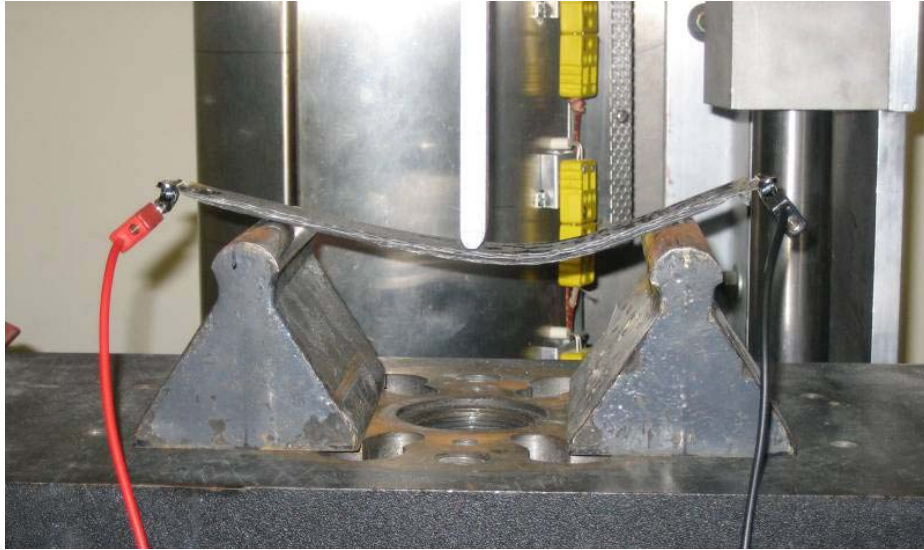
Figure 28. Carbon fiber Mode II resistance testing in bent position.

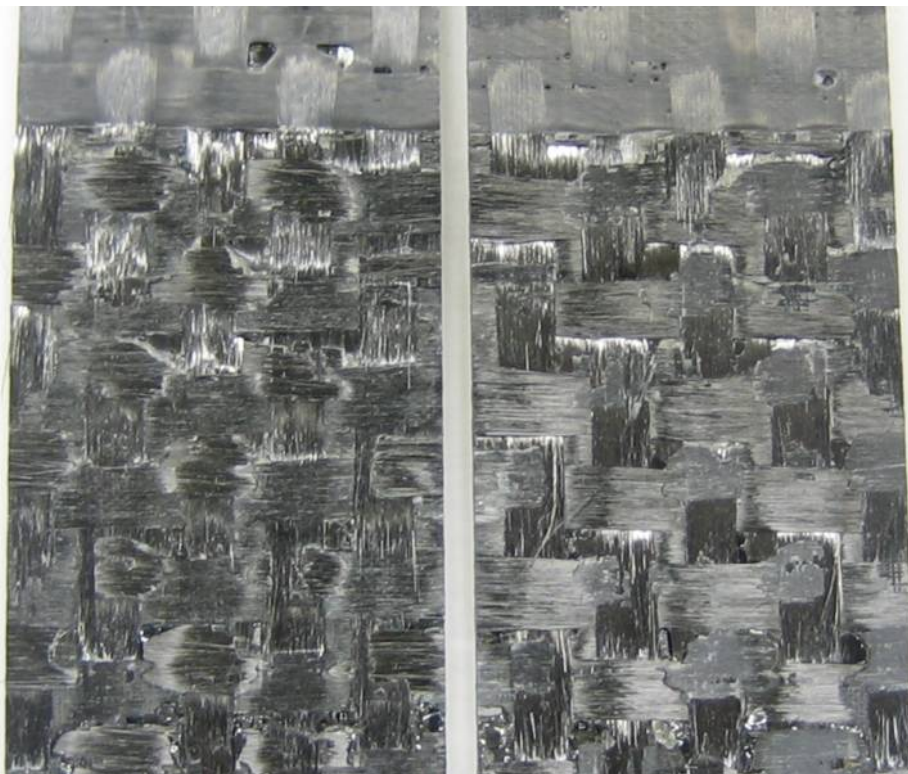
Figure 33. Crack propagation path of carbon fiber composite without CNTs.

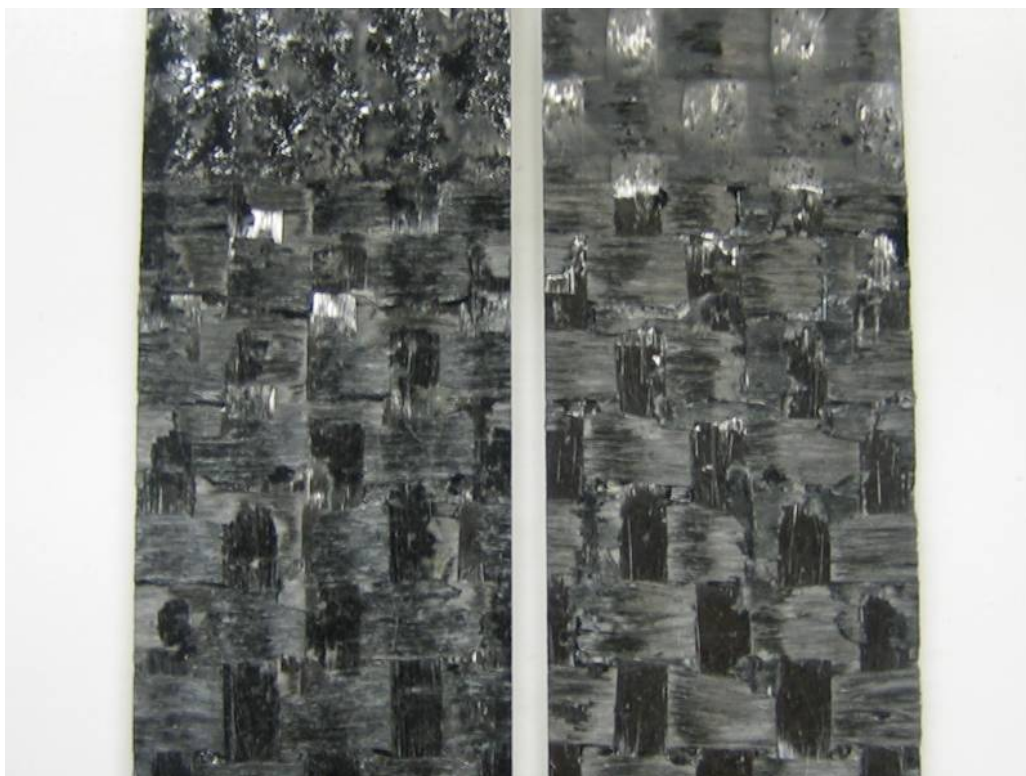
Figure 34. Crack propagation path of carbon fiber composite with CNTs.
